SERVICE SLANTS

ISSUED BY WURLITZER SERVICE DEPT., NORTH TONAWANDA, N. Y.

November 8, 1947

SUBJECT: PART NO. 45617 RELAY FOR MODEL 216 IMPULSE RECEIVER.

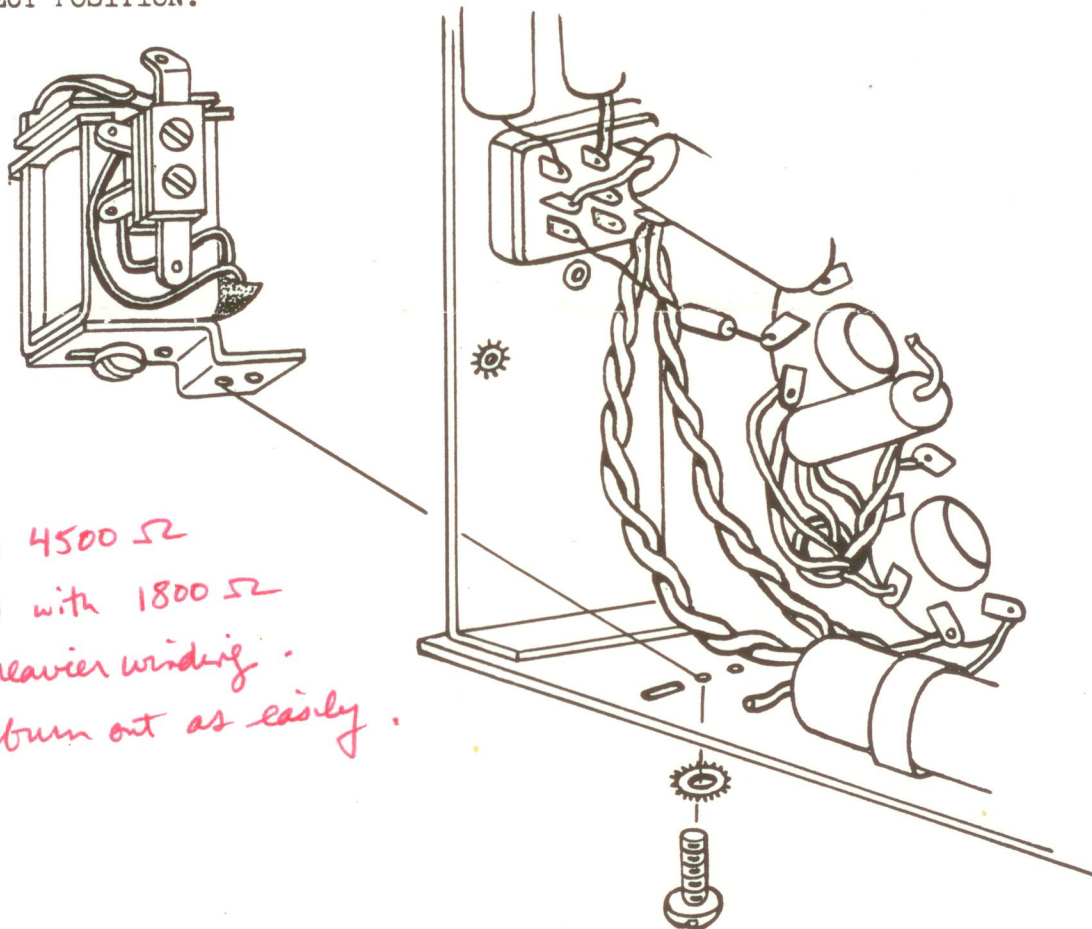
Part No. 45617 Relay has been obsoleted and is no longer available. Part No. 48813 Relay has been substituted in production, and will be shipped in place of the obsoleted item in all parts orders as Part No. 48833.

Part No. 48833 Relay is supplied mounted to a bracket. If used to replace a relay of the same type in a later Model 216 Receiver, the bracket is removed and the relay installed in the same manner as the original relay.

In early Model 216 Impulse Receivers, the method of installing Part No. 48833 Relay is illustrated below. NOTE THAT MOUNTING BRACKET IS SHOWN IN CORRECT POSITION.
